Plasmor Grain Silo Lowestoft, Suffolk

Concrete Repair and Protection

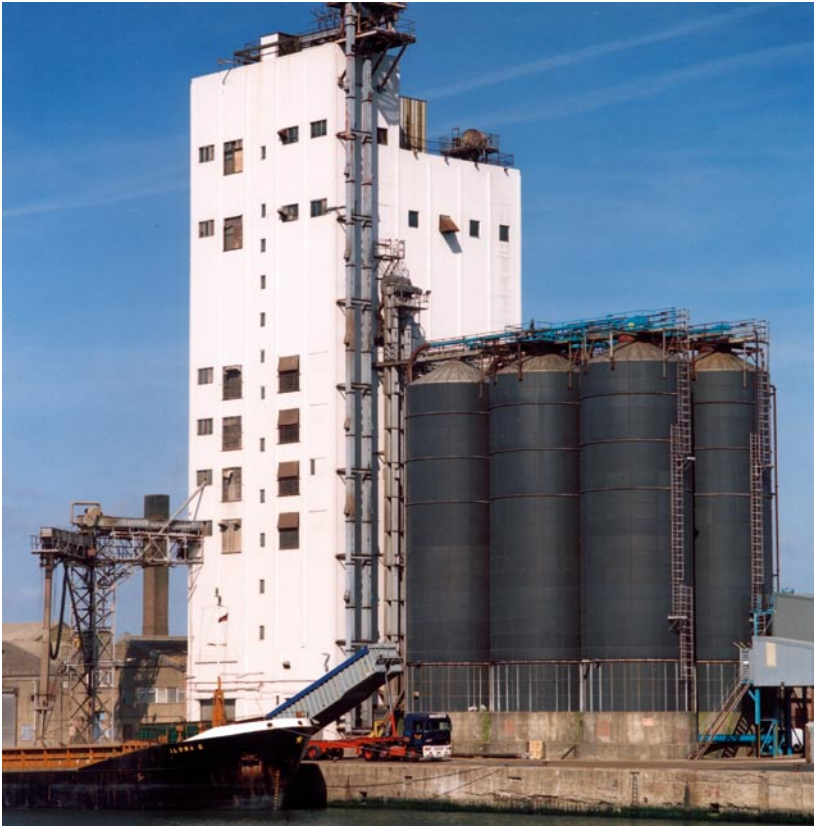
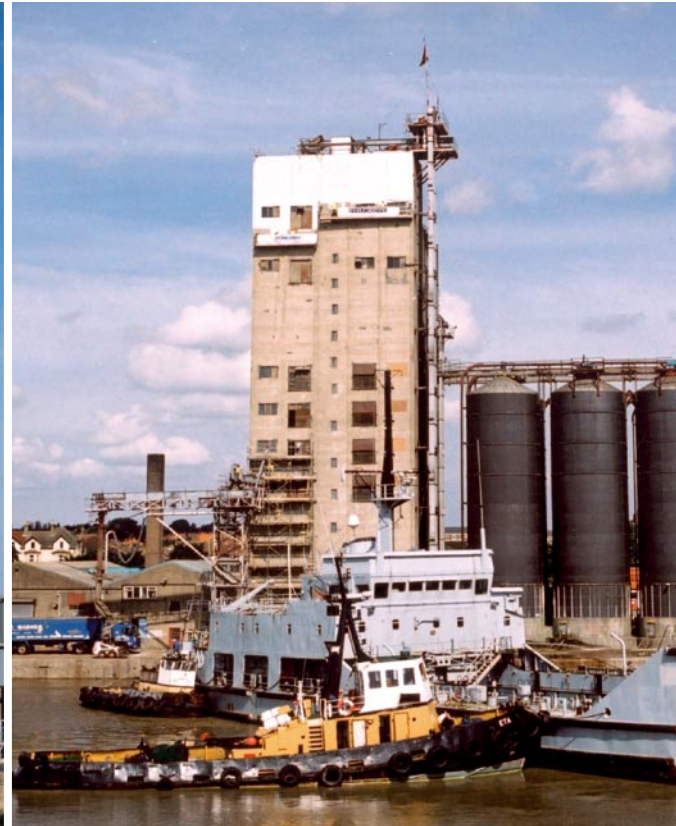
Folcrete Restoration Services Limited are the UK's leading refurbishment specialists for the Milling Industry. Folcrete were called in when the 75m high, 13,500 tonne capacity, monolithic concrete grain silo owned by Plasmor on Lowestoft Docks, was suffering from cracking and spalling concrete.

Following this cracking, water ingress into the structure had begun to accelerate the rate of deterioration. This was due to chlorides from the marine atmosphere accelerating corrosion of the exposed steel reinforcement.

All of the damaged concrete was removed, the corroding steel reinforcement was exposed and treated, then all of the surface defects were repaired with Remmers Repair and Fairing Mortars. Finally the whole structure was protected with Remmers Concrete Acrylic and Elastoflex Anti Carbonation Coatings.
