Grain silos, Karstädt, Germany

Reference data

- **Building activity**
Concrete restoration
- **Object type**
Agricultural objects
- **Area**
45.000 m²
- **Object address**
, 22761 Hamburg
- **Date / Completion**
2013
- **Architect**
UHR Betoninstandsetzung GmbH
- **Viewing possible?**
No

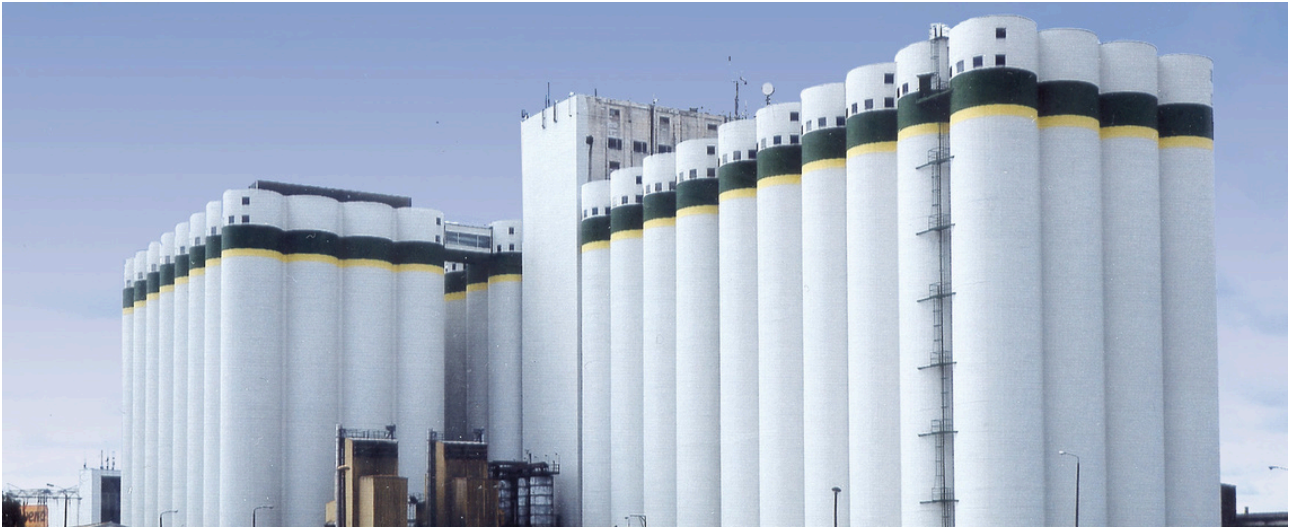
The plant was built in the 70's during the GDR era. The complex consists of round cell silos with 45,000 m² of concrete surface for the storage of grain and a compound feed plant with 10,000 m² outdoor surface area.

The reinforcement had too little concrete coverage and the quality of the concrete also varied. This led to corrosion damage and concrete spalling. Since 2005, stricter regulations of the food law and hygiene regulations have been in force, which had to be observed. This meant that all surfaces had to be cleaned with a high-pressure cleaner at 500 bar water pressure in order to reach solid ground and to determine the true extent of the damage.
