REFERENCE

Travelodge, Manchester Central, Manchester

Brief Description

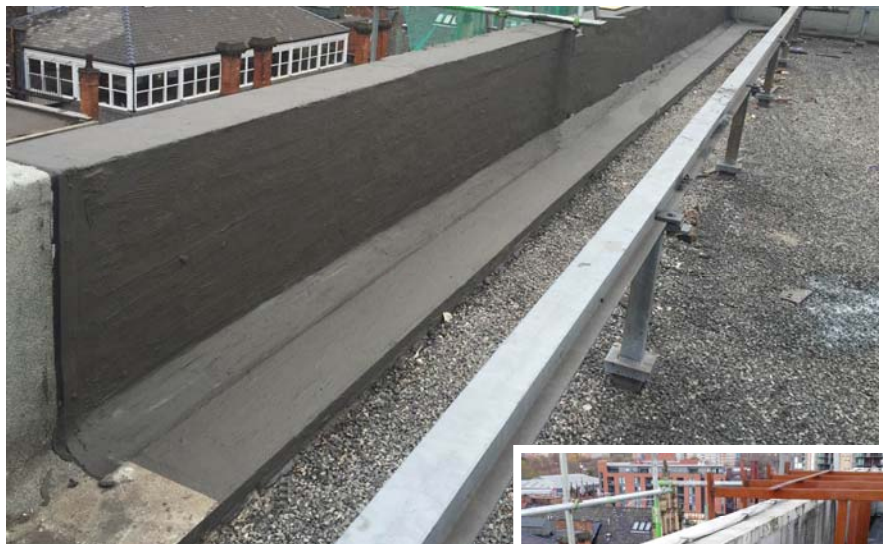
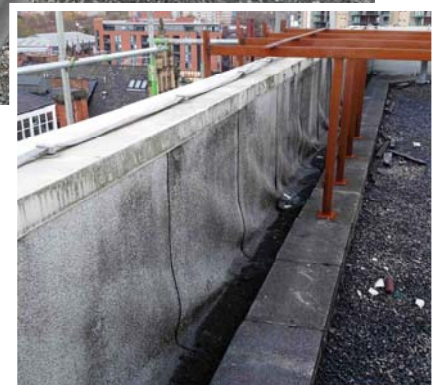
The building had been suffering from water ingress from the roof for a number of years which had gradually worsened over time. This had led to water damage to the interior and had highlighted problems with the parapet concrete wall above. The failed areas of waterproofing required replacing with a flexible waterproof system which could be terminated over the parapet wall and into the existing waterproofing.

Kiesol
Multi-Tight 2K
Waterstop VF
