REFERENCE

Milking Sheds, Stölln

Brief Description

To re-profile a concrete milking shed floor with a coating which can withstand heavy cattle abrasion and lactic acid.

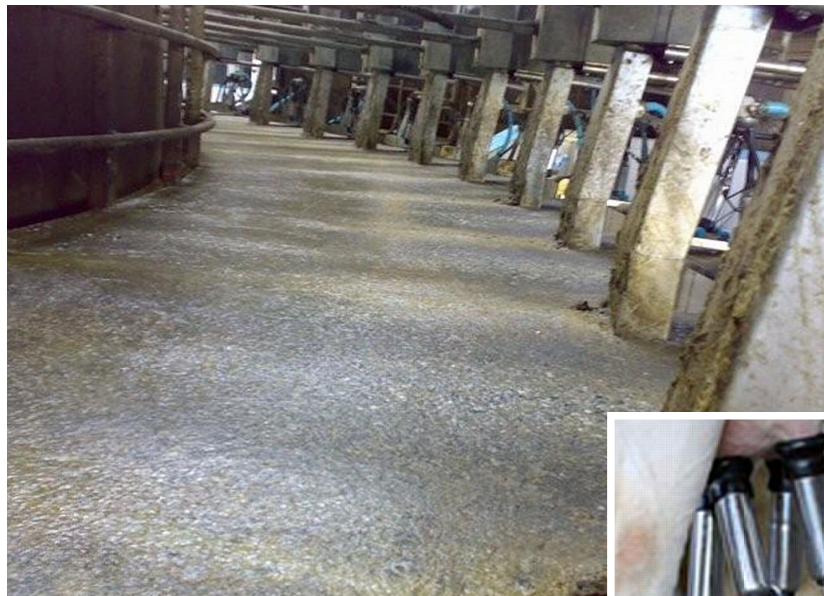
Heavily pitted concrete and chemical damage from lactic acid development.

The concrete was very humid/wet and the surface had to have very high slip and abrasion resistance.
