# Barclays Bank Newport, South Wales

Stone Cleaning and Restoration

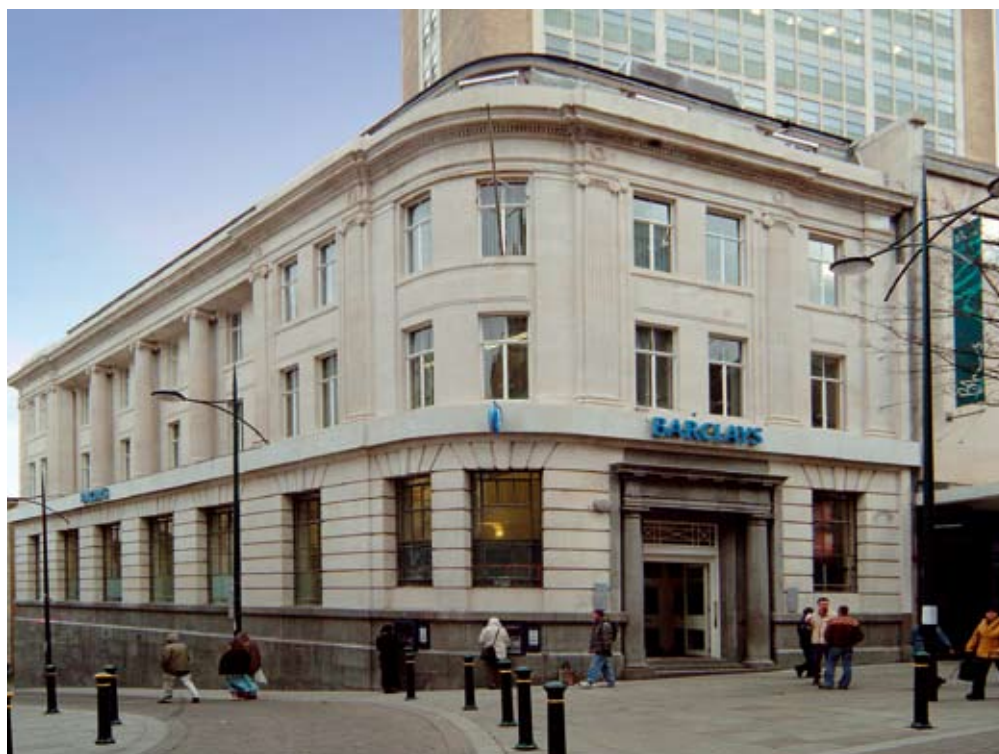
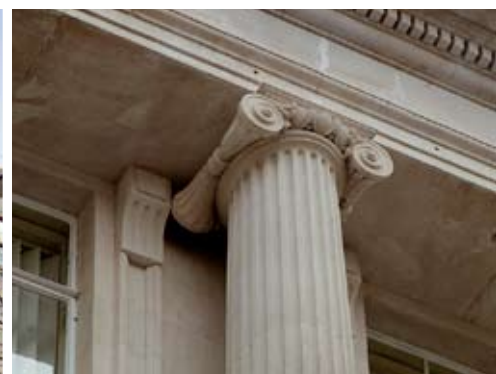
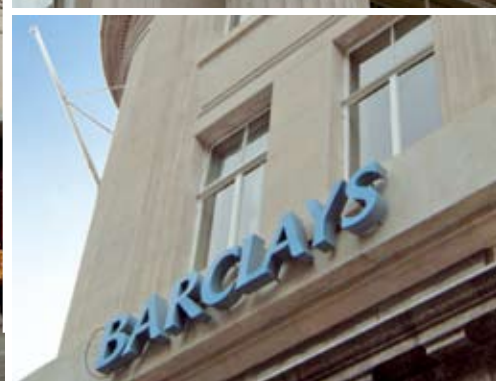
The City Centre branch of Barclays Bank in Newport, South Wales has just undergone a comprehensive external refurbishment. The traditionally stone built Victorian building is faced with polished black granite to a dado line at street level, with the remainder of the facade, including the carved and decorative columns, in a local limestone.

At the start of the refurbishment planning, Donaldsons the managing surveyors, contacted Remmers for advice and assistance in developing the correct stone cleaning process for the different stone surfaces. All of these had a heavy build up of carbon deposits plus other dirt and grime from the traffic and exposure.

Remmers Alkutex® and Intachem® specialist stone cleaning systems were selected

as they were able to dissolve and therefore allow removal of all of the deposits, with absolutely no detriment or damage to the polished granite, or to the acid sensitive limestone surfaces.

The works were all carried out by specialist restoration contractors Pamarch 1997 Limited, who were also recommended by Remmers, because of their experience with this type of project and the use of Remmers cleaning and restoration systems. Areas found to require additional stone restoration were repaired using Remmers Restoration Mortar. This was colour matched to the original surrounding stone, with Remmers Epoxy Mortars also used to fix reinforcing dowels where required by the engineer.

Finally to protect the cleaned and restored facade from future damage and any further build up of carbon deposits, Pamarch

treated the whole surface with Remmers high performance Funcosil® SNL, a one component hydrophobic impregnation, applied by low pressure spray.
