Weetabix 'Corby One'

Corby, Northants

This major breakfast cereal production facility is known as 'Corby One' in Corby, Northamptonshire. It has had its external concrete fabric repaired and protected by Folcrete Restoration Services Limited using Remmers complete concrete repair and protection system.

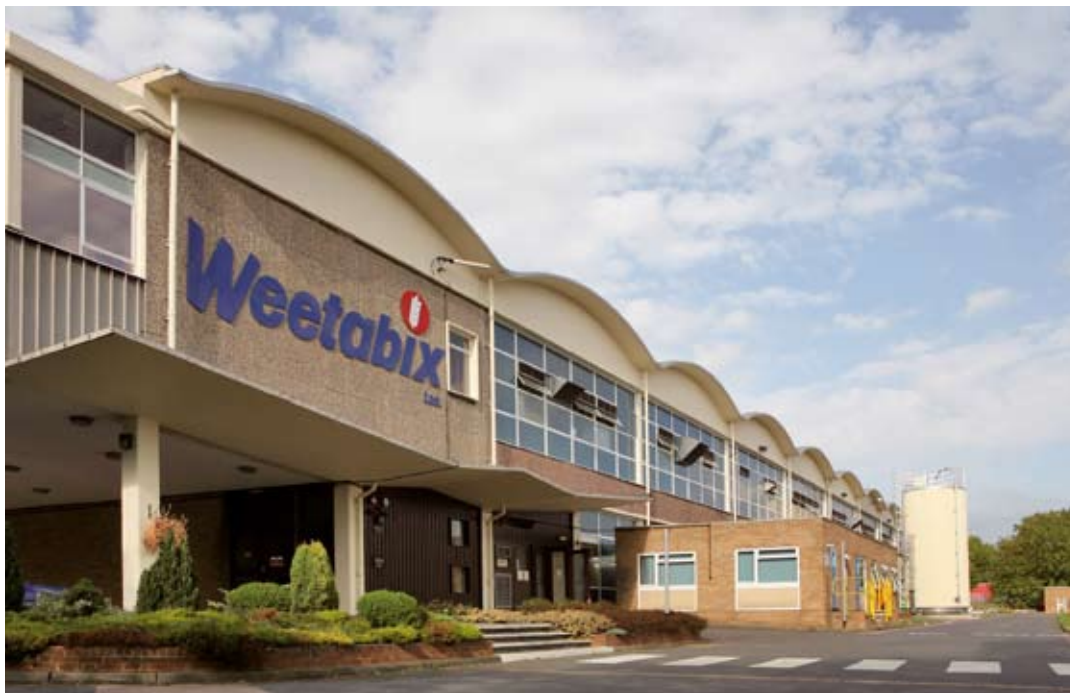
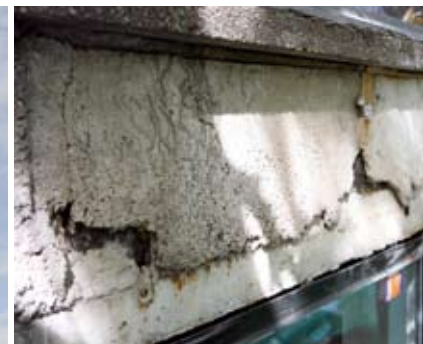
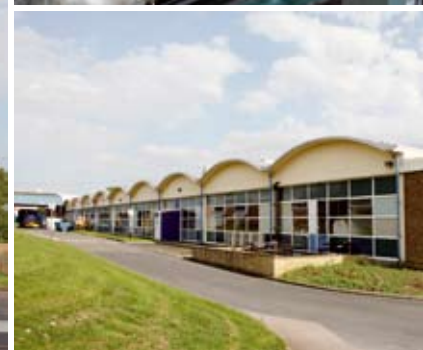
The most serious problems had arisen in the columns, where a

combination of low cover and honeycombing, from inadequate compaction in the original construction, had allowed water ingress and the main vertical reinforcement had begun to corrode. This created a vicious spiral of more cracking, more concrete spalling and even more water ingress.

The solution involved high pressure water jetting to clean all of the concrete surfaces, followed by mechanical breakout of the damaged areas and blastcleaning of any exposed steel reinforcement.

The damages were repaired using Remmers repair mortars, including Betofix® RM Lightweight for the overhead repairs to the edges and details of the roof slab. This advanced mortar can quickly be built up in layers – even in overhead applications.

Overall the repaired concrete

surfaces were then sealed and protected by the application of Remmers Concrete Acrylic, the anti carbonation coating, including a Clear Glaze grade for the exposed aggregate surfaces.
