# Tower block, Germany

## Reference data

- **Building activity**  
Façade restoration / render
- **Object type**  
Multi-family housing
- **Area**  
202 Balconies
- **Object address**  
, 40699 Erkrath
- **Date / Completion**  
2018
- **Viewing possible?**  
No

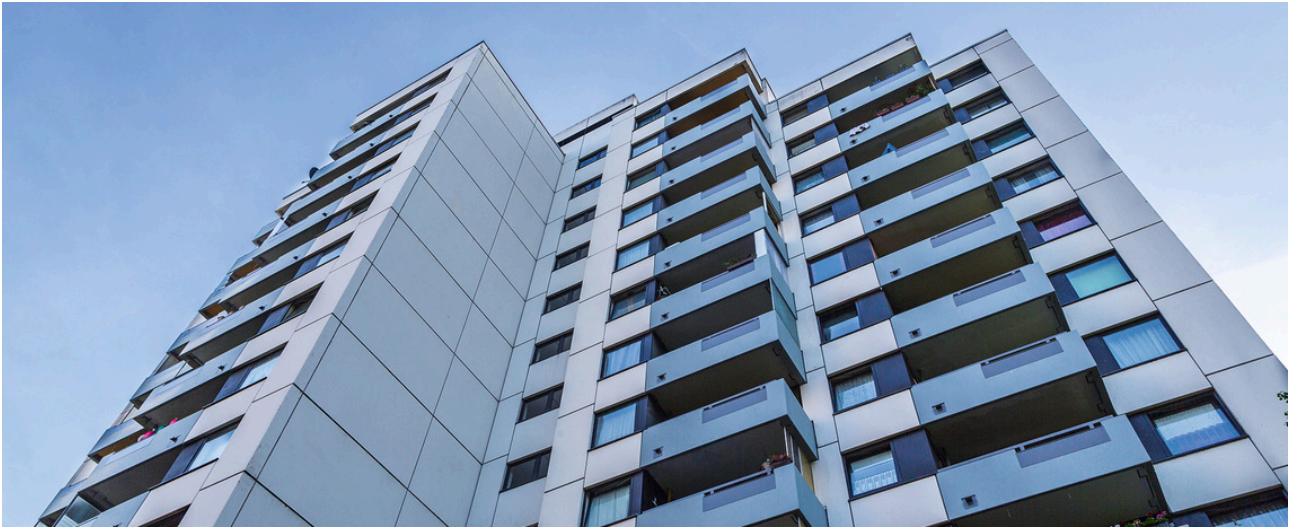
The building, which is about 40 metres high, was built in the 1970s. 202 balconies, distributed over the two building fronts, were to be renovated and repaired. The concrete surfaces of the balconies required renovation. For the typical concrete fascias, repair was out of the question. In order to save costs, the entire refurbishment was carried out with the aid of rope-operated suspended scaffolding. This was lowered from the roof which made it possible to renovate 13 balconies in one step.

The concrete surfaces of the balcony parapets were repaired and a surface protection was applied. This has a hardening effect, is alkali-resistant, open to water vapour diffusion and water-repellent. The prepared substrate was then painted with a mineral paint in accordance with a specified colour concept. In order to implement this individual concept, a special colour shade was produced that exactly met the customer's requirements. The balcony fronts were replaced and covered with a metal sheet.
